# DDASaccident817

Humanitarian Demining Accident and Incident Database  
*AID*

# DDAS Accident Report

Deminer Killed by Explosive in Pailin, January 13, 2017

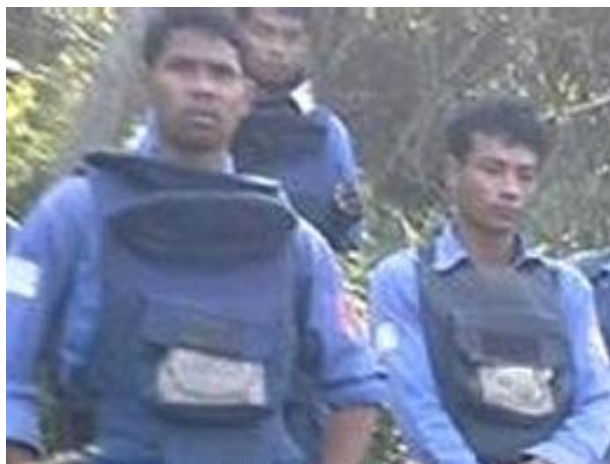
Victim No.2's facial injuries shown indicate that either she was not wearing a visor or that the visor was raised. That Victim No.2 also suffered body injuries implies that she either was not wearing her body armour or that it was too small to provide appropriate protection.

Victim No.1's head is concealed in the photograph but his hands are shown and appear to be uninjured. This implies that he was using a long tool of some kind that may have broken up and caused his injuries. That he suffered a fatal fragmentation injury to his head from a small

blast mine indicates that his blast visor was not worn, or not worn correctly, and (in the absence of other information) implies that his hand tool caused his injury.

This demining organisation's body armour is shorter than most and usually does not have a collar to interface with the visor and prevent blast entering beneath the visor. However, in this accident the photograph shows one deminer wearing armour has been fitted with a collar to interface with the visor (which is a welcome improvement) but only on two of the four armours shown.
